# Water treatment plant

- 2.4 m diameter Weholite tank

## Aeration tank to improve the water quality

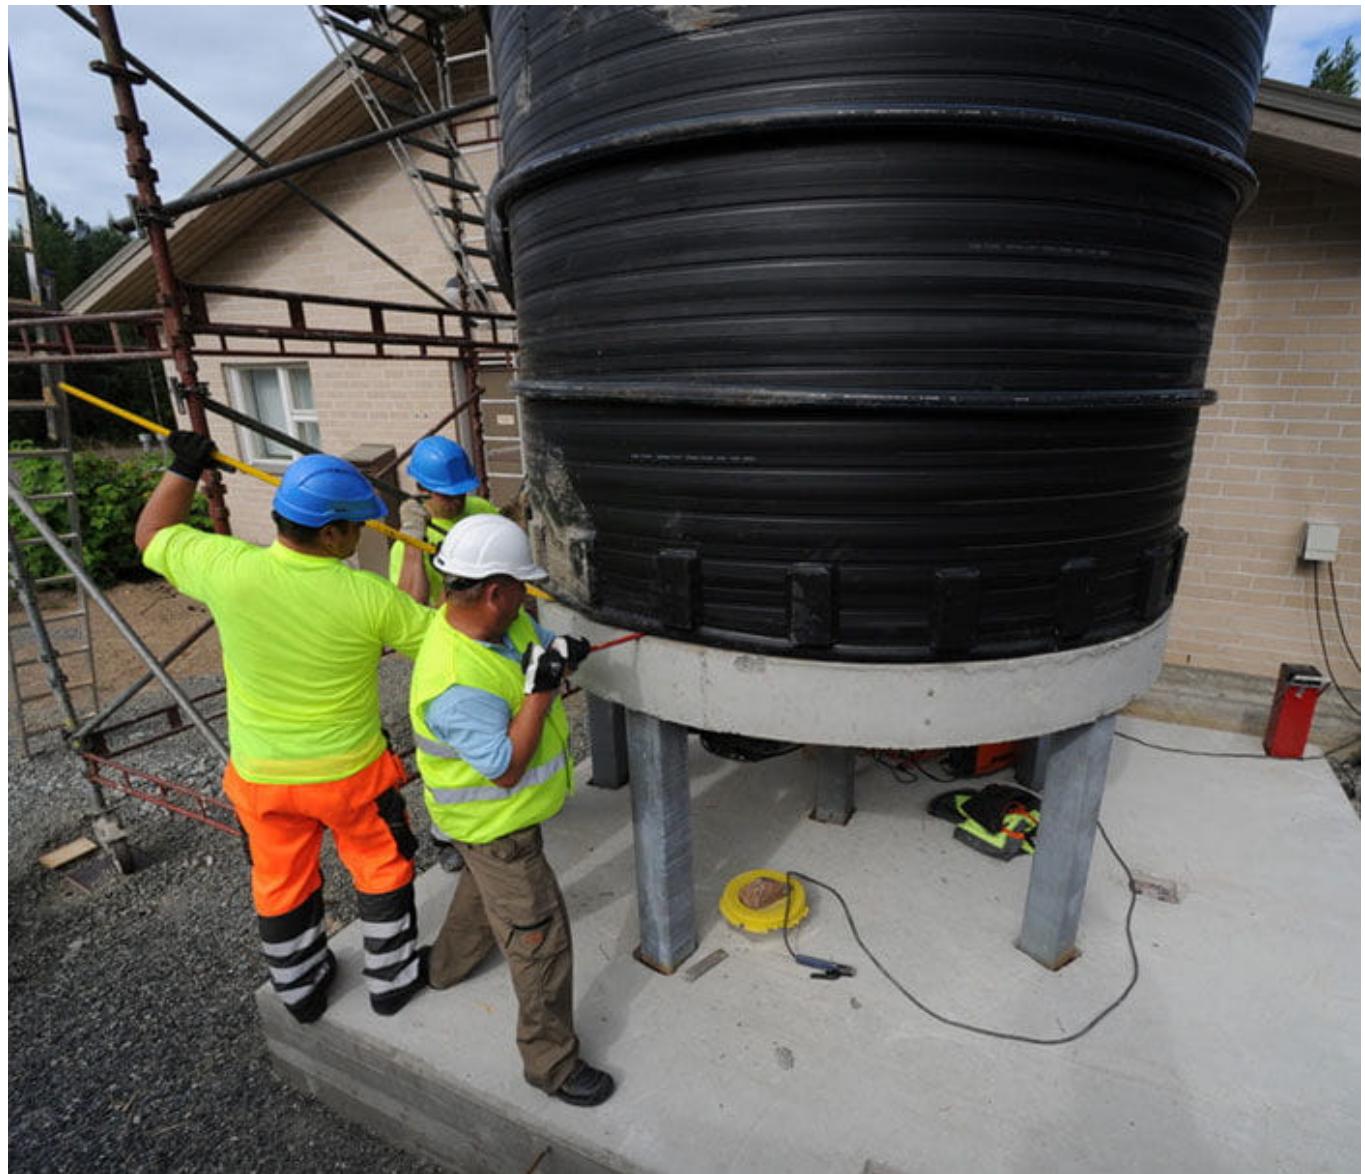
## Weholite aeration tank

In aeration that improves water quality, water is led to the tower from above. The water flows through the infill mattress in the tower, removing the carbon dioxide in the raw water. Aeration can be adjusted by blowing clean air under the tower through the mattress upstream.

The amount of air does not require the tower to withstand greater pressure than normal in normal use, but the Weholite tank can also withstand the full water pressure of the tank, for example in the event of washing or disturbances.

- The concrete slab under the tower had already been made in advance. On top of the base slab, we installed feet just over a meter high, on which we lifted a round concrete slab. The tower was attached to it, says work manager Kalevi Savolainen.

Valves and piping were installed in the space under the tower. The insulation of the lower part was also supplemented. The finished tower was raised with a truck crane. - The work went as planned. Already during the installation work, guests visited the site. The insulated aeration tank is interesting because there is little space for such massive structures in a few places, Savolainen says. The contractor completed the tower by installing exterior cladding.
