In place in a couple of days

The waste water channel for the pulp line of the mill, which was renovated in 2017, was commissioned in the 1960s. Now there were fear that it would collapse. The new solution was Weholite.

Location	Completare
Oulu, Finland	2017

Tipul proiectului
Renovation

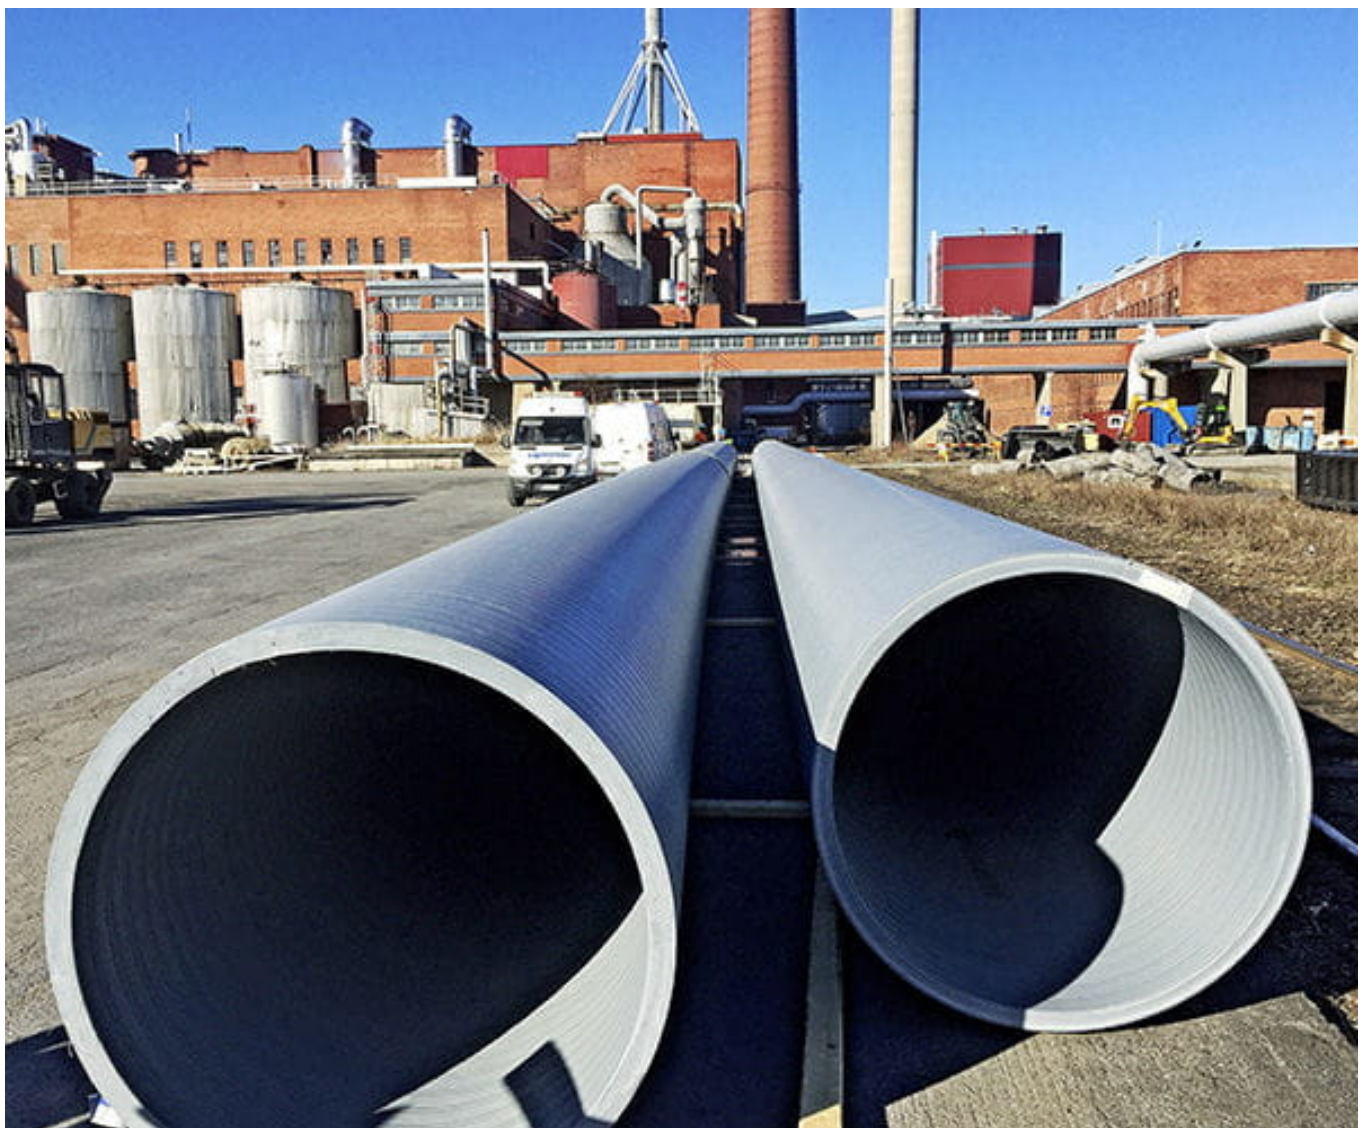
In place in a couple of days

Work on installing the pipes could begin about midday on the Tuesday of the maintenance stop week, by which time a bypass pump for sludge from clean water production had been installed. In addition, the gravel and sludge layer that had gathered on the bottom of the channel had to be removed before the new pipes were installed. The renovation was begun by feeding the

first pipe into the channel under the factory building.

“When the pipe fed under the building was in place, an excavator was used to insert the other 42-metre long pipe into the channel outside the building.”
