Water treatment plant

2.4 m diameter Weholite tank

Aeration tank to improve the water quality

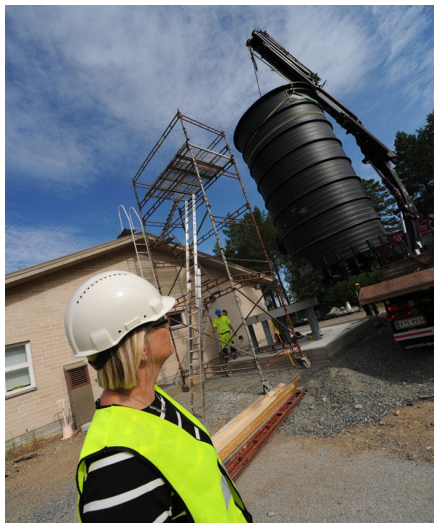
Weholite aeration tank

In aeration that improves water quality, water is led to the tower from above. The water flows through the infill mattress in the tower, removing the carbon dioxide in the raw water. Aeration can be adjusted by blowing clean air under the tower through the mattress upstream.

- The concrete slab under the tower had already been made in advance. On top of the base slab, we installed feet just over a meter high, on which we lifted a round concrete slab. The tower was attached to it, says work manager Kalevi Savolainen.

Valves and piping were installed in the space under the tower. The insulation of the lower part was also supplemented. The finished tower was raised with a truck crane. - The work went as planned. Already during the installation work, guests visited the site. The insulated aeration tank is interesting because there is little space for such massive structures in a few places, Savolainen says. The contractor completed the tower by installing exterior cladding.
