Quick installation in the Konotopa channel

- ✔ Weholite pipes PEHD SN4 DN2000 mm – 165 m

Weholite guaranteed a simple and quick installation in the Konotopa channel

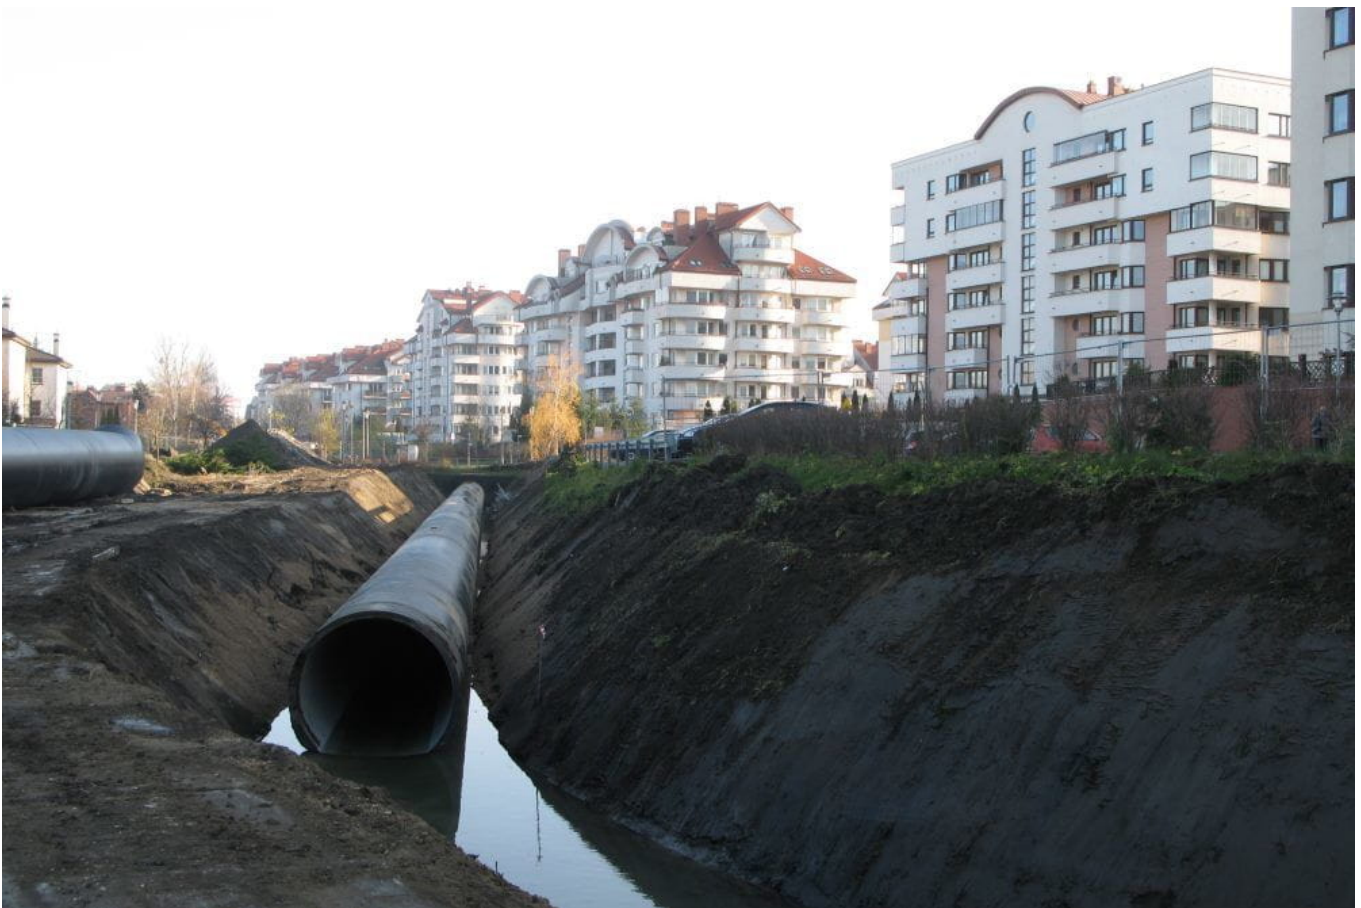
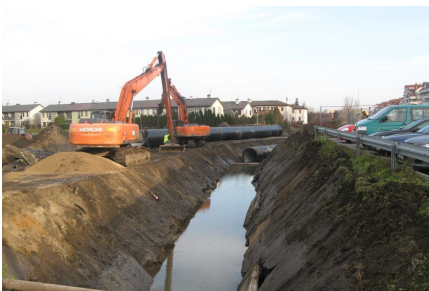
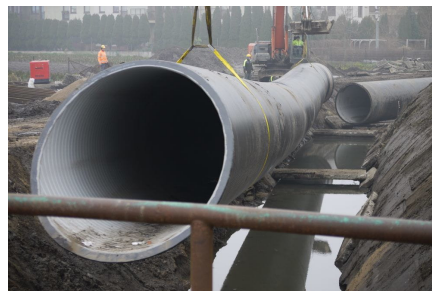
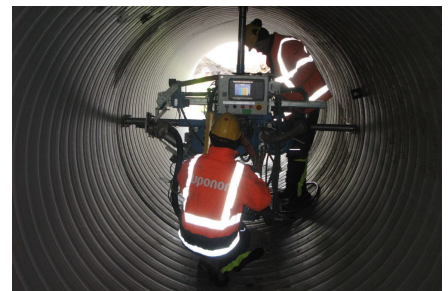
Weholite guaranteed a simple and quick installation in the Konotopa channel

Following a tender, in September 2016 Drainage Construction Company Tolos was appointed as the general contractor for the project. Uponor Infra delivered a total of 165 metres of structured-wall PE-HD Weholite, DN/ID 2,000mm SN4 pipes to the installation site. Prep work included clearing the channel of concrete slab lining, dredging the ditch to make room for the new pipeline and laying the bedding. Uponor Infra pipe service staff then joined up the Weholite pipes to form two sections. The work was carried out on dry land on the right bank of the channel, by means of automatic extrusion welding using a WLI- 3000 machine. This guaranteed the 100% tightness and homogeneity of the pipeline. A 100- metre section of pipeline was then lowered into the ditch, followed by the remaining 50-metre section with a fitted bend two days later. Since the channel was operational during installation, the two connecting sections of the pipeline were raised above the water level, where they were welded together. The pipeline was then connected to a reinforced concrete inlet of the underground section of the channel. A socket- and- spigot DN/ID200mm joint was fitted onto the pipeline, connecting it to an existing stormwater channel. Finally, the ditch was backfilled. At the spot where the new pipeline meets the open section of the channel, an outlet was secured with a steel grate to prevent unauthorised entry. The installation was completed in December 2016.
