## Water treatment plant

## Aeration tank to improve the water quality

Water company Ylä-Savon Vesi Oy needed a solution to improve the water quality in water supply process. The solution was an aeration tank made of Weholite.

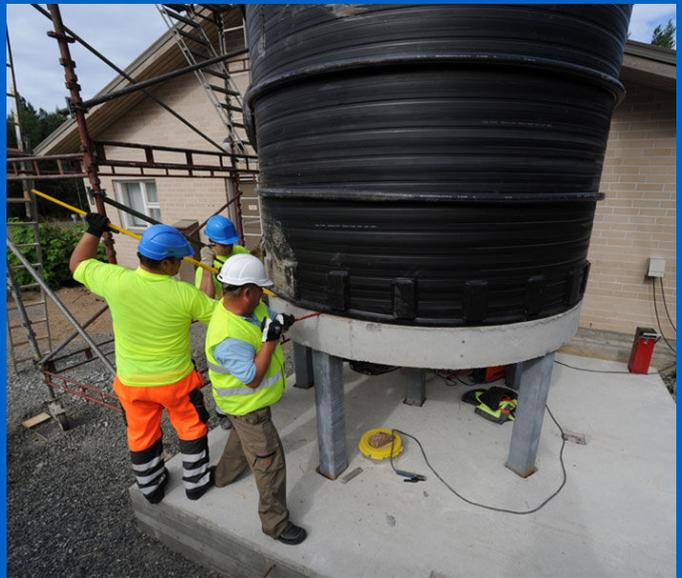
2.4 m diameter Weholite tank

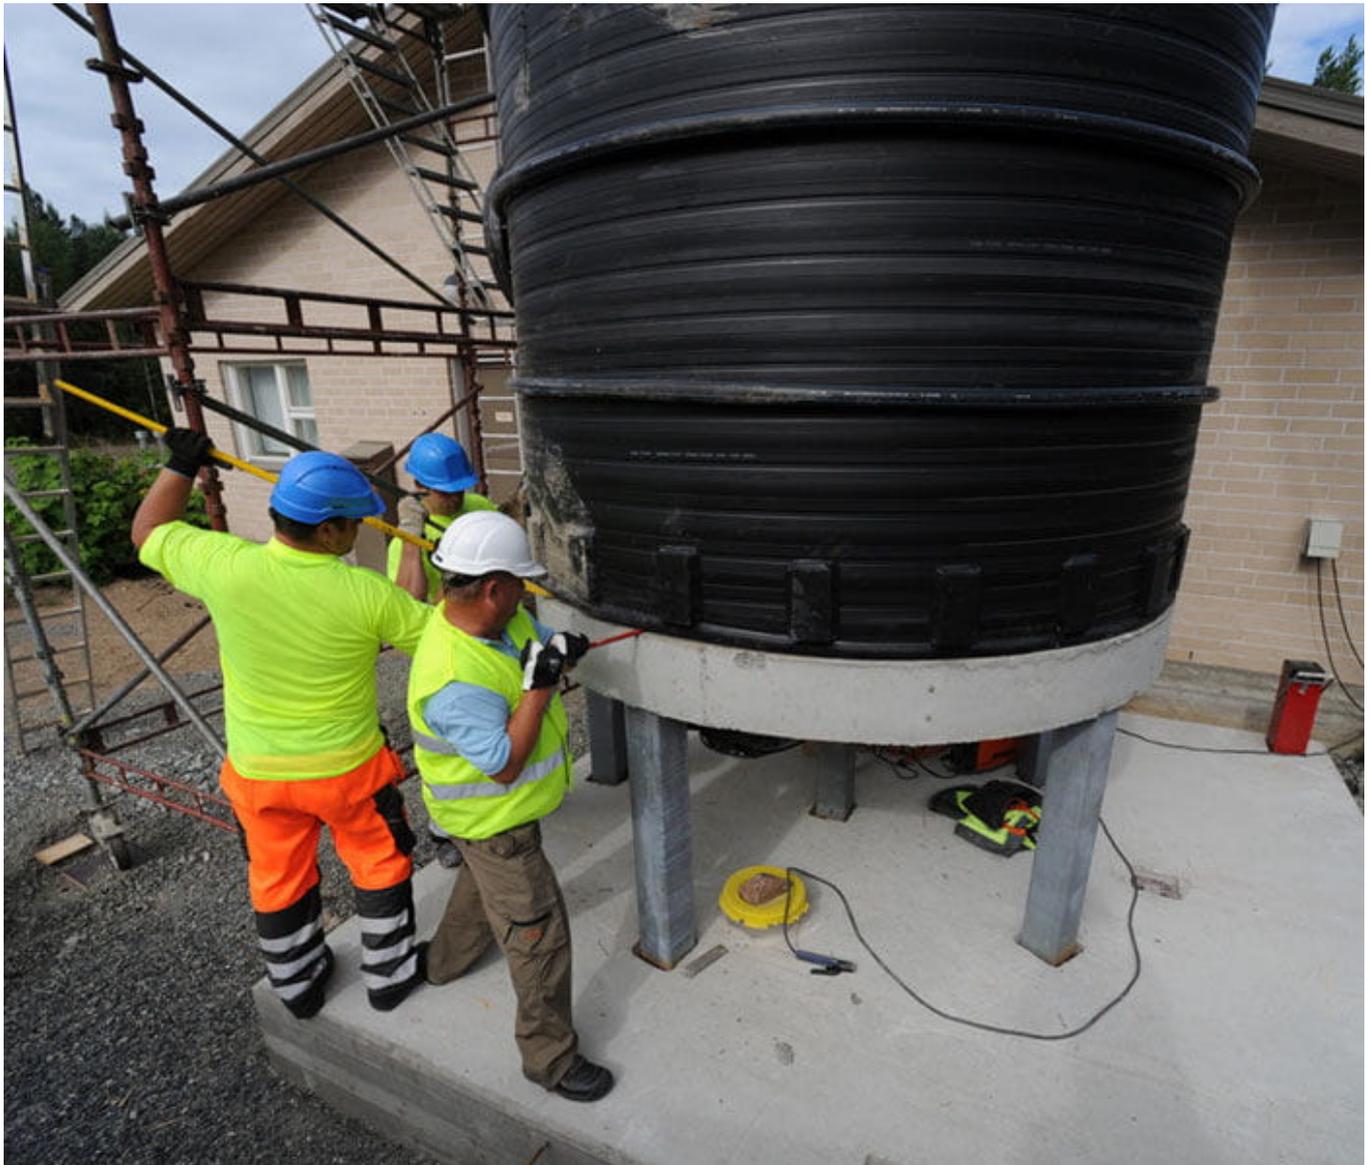
## Weholite aeration tank

In aeration that improves water quality, water is led to the tower from above. The water flows through the infill mattress in the tower, removing the carbon dioxide in the raw water. Aeration can be adjusted by blowing clean air under the tower through the mattress upstream.

- The concrete slab under the tower had already been made in advance. On top of the base slab, we installed feet just over a meter high, on which we lifted a round concrete slab. The tower was attached to it, says work manager Kalevi Savolainen.

Valves and piping were installed in the space under the tower. The insulation of the lower part was also supplemented. The finished tower was raised with a truck crane. - The work went as planned. Already during the installation work, guests visited the site. The insulated aeration tank is interesting because there is little space for such massive structures in a few places, Savolainen says. The contractor completed the tower by installing exterior cladding.
