## Plastic pipe withstands mill's process water

Stora Enso's Imatra mill, located in southeast Finland, annually produces one million tonnes of packaging paper and board. The Imatra mill's two production units produce raw materials for cartons, in which juice and milk are packaged. Board is also used to produce paper cups, as well as cigarette and candy packages. Board for the graphics industry is used to produce cards, covers and luxury packages.

The process water required in the manufacture of board and paper has thus far run through concrete channels to the treatment process facility, after which the water has been discharged into Lake Saimaa. The hot water that contains chemicals has worn down and eroded the concrete structures so much that a new solution had to be found for transporting the process water.

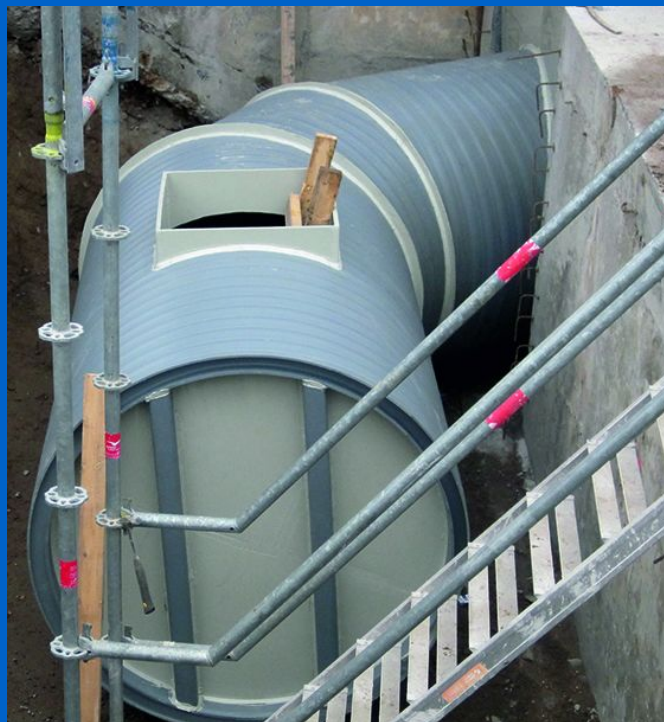
During the first stage, seventy metres of pipe, with a diameter of 1.6 metres, was installed at the mill. The pipe was slid into the existing concrete channel. Additionally, two segment bends were installed in preparation for the project's second stage. At that time, a further 120 metres of pipe will be added to the system and buried underground. As the pipeline will curve back and forth, completion of the installation work will require the addition of five or six segment bends. Dite manager Kimmo Sjöman oversaw the preparation and installation work during the first stage of the project at Imatra.

According to Mr Sjöman, sliding the stiff pipe into a square tunnel was somewhat difficult, as there was little space and the pipe did not bend easily. The outside diameter of the pipe was 1.8 metres. The pipe was slid into a square tunnel that was 2 x 2 metres in size.

"It was a tight fit, but we were successful," Mr Sjöman recounted. During the slip lining procedure, a wire was attached to one end of the pipe, which made it possible to pull the pipe into the tunnel.

Excavators then pushed the piping into the concrete channel. According to Mr Sjöman and Mr Tiilikainen, the installation was completed successfully and within the agreed timeframe. However, there were small setbacks during commissioning, when a small leak was observed in an inspection chamber. The cause of this leak was fixed by sealing up the welding seams. Everything was ready for the project's second sta
